SHANNON ENGINEERING, INC.

SUMMARY LETTER ON THE FEASIBILITY REPORT ON INDIVIDUAL ONSITE WASTEWATER SYSTEMS FOR VAL MORITZ VILLAGE, BLOCK 3, FILING 1

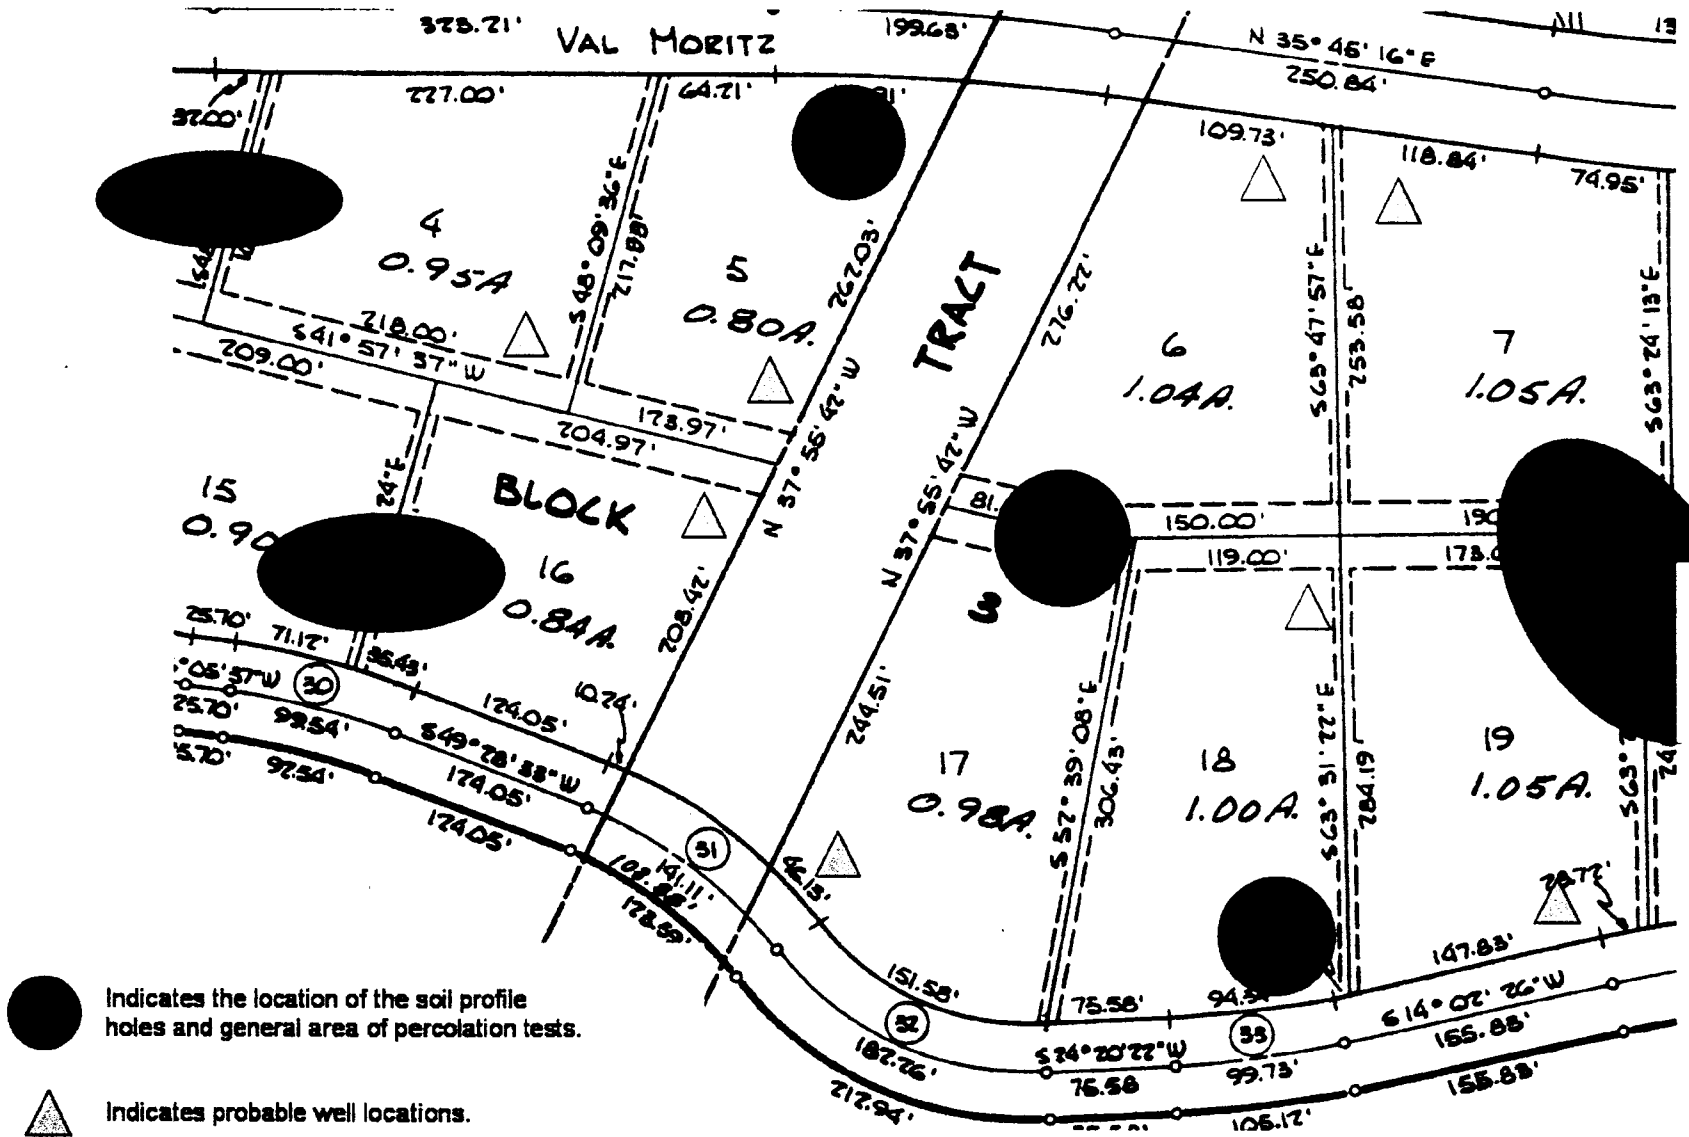
Filing 1, Block 3
Val Moritz Village

Infiltration Test OK at 2 gal./ft.²/day

Infiltration Test OK at 1 gal./ft.²/day

Profile Combo w/23
