# **VAL MORITZ VILLAGE**

## **FEASIBILITY REPORT ON INDIVIDUAL ONSITE WASTEWATER SYSTEMS FOR FILING 2, BLOCK 1**

**Prepared by:  
Shannon Engineering, Inc.**

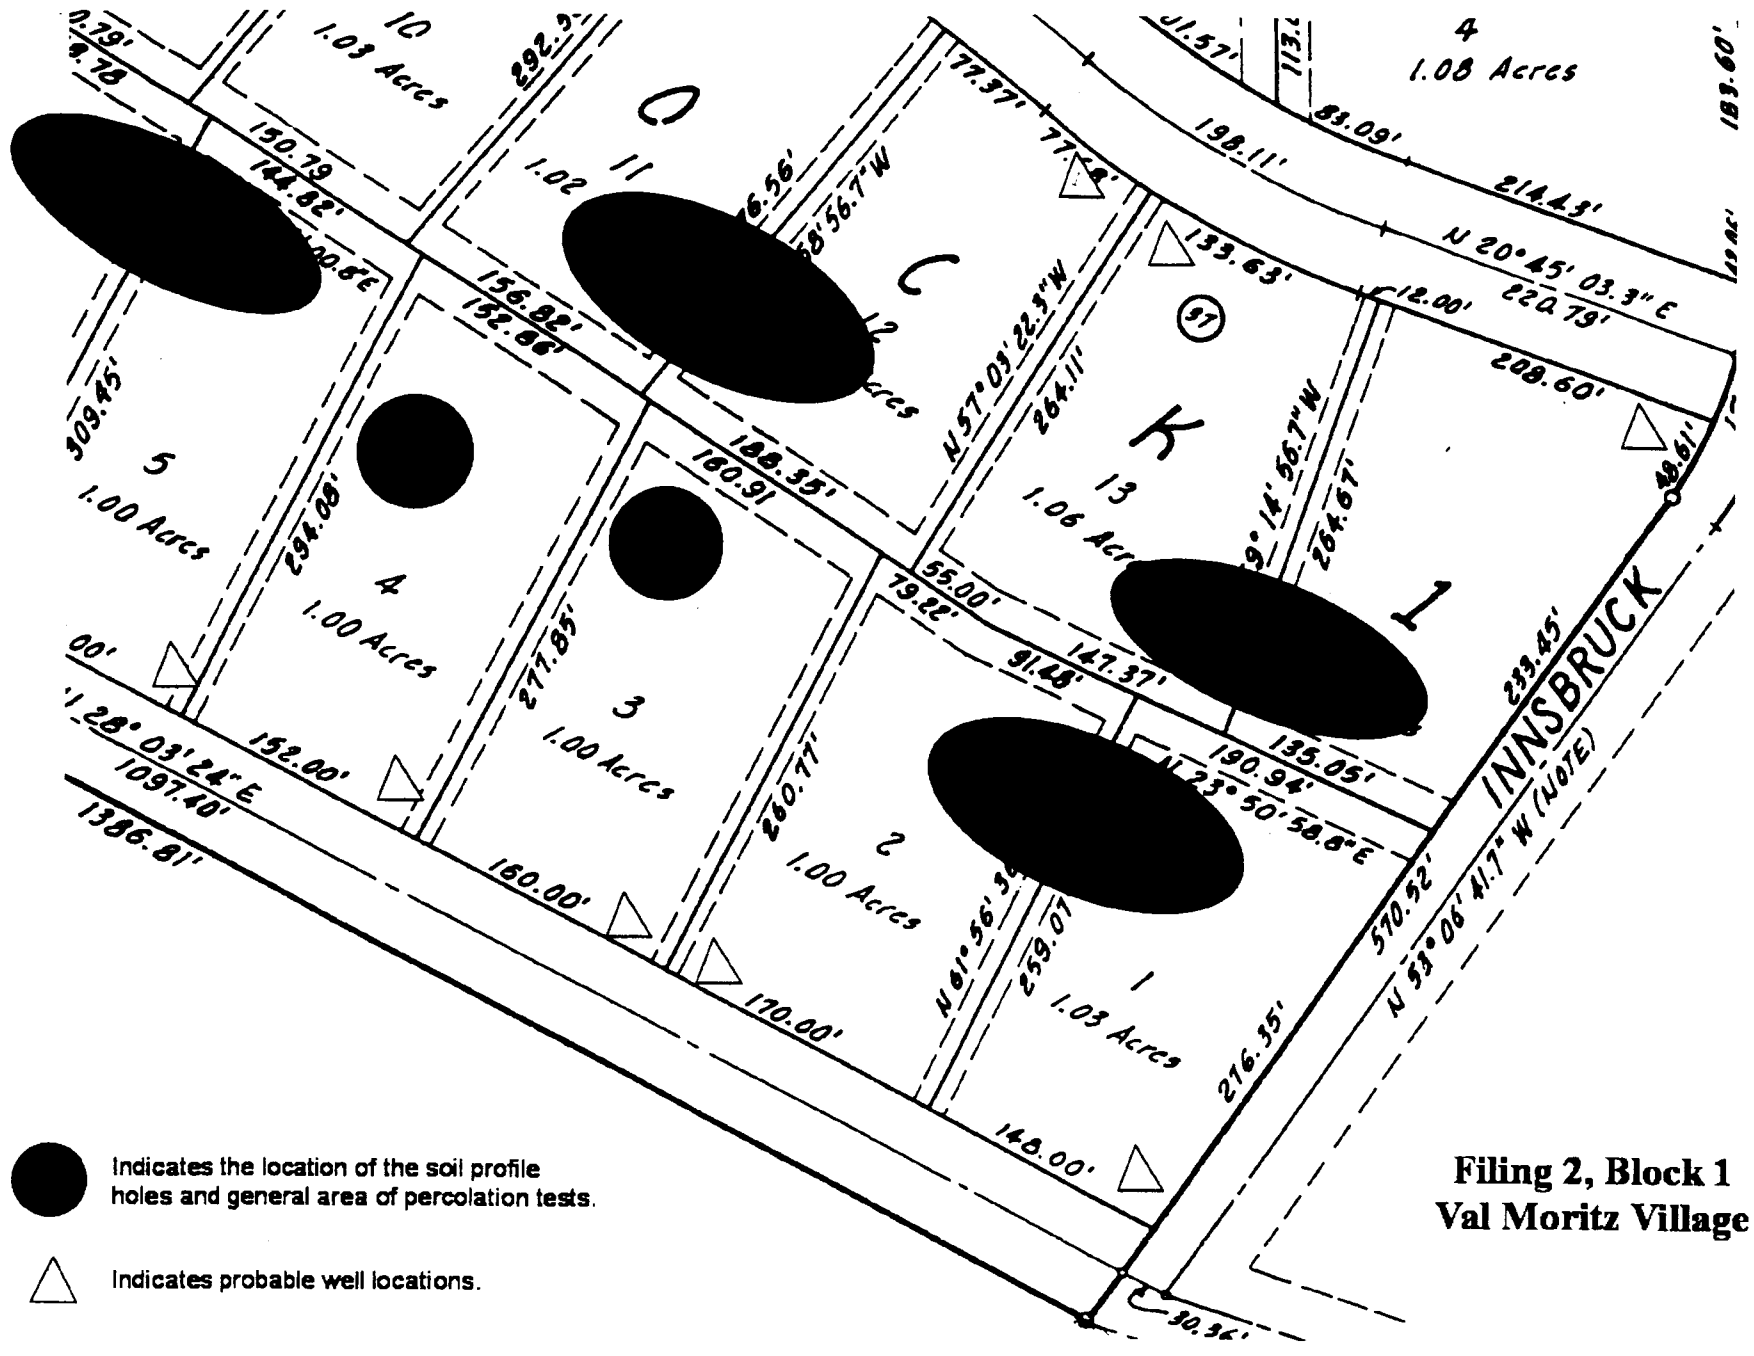
**Filing 2, Block 1  
Val Moritz Village**

● Indicates the location of the soil profile holes and general area of percolation tests.

△ Indicates probable well locations.

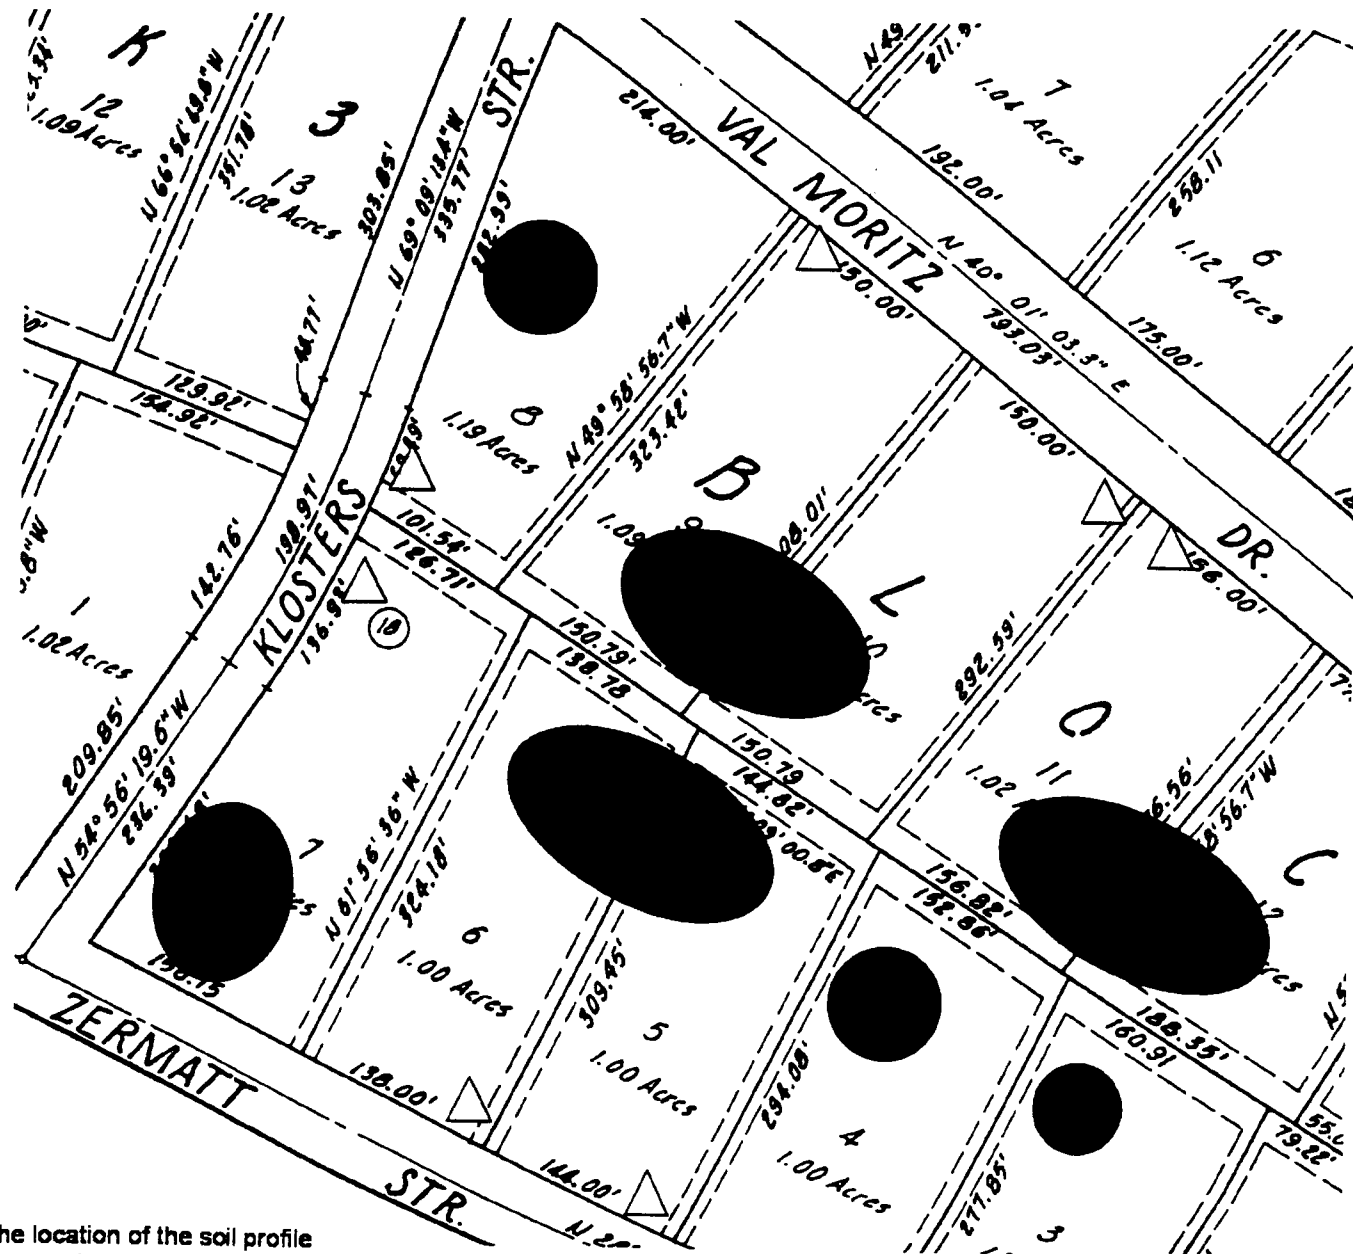
Indicates the location of the soil profile holes and general area of percolation tests.
