VAL MORITZ VILLAGE

FEASIBILITY REPORT ON INDIVIDUAL ONSITE WASTEWATER SYSTEMS FOR FILING 2, BLOCK 4

**Prepared by:
Shannon Engineering, Inc.**

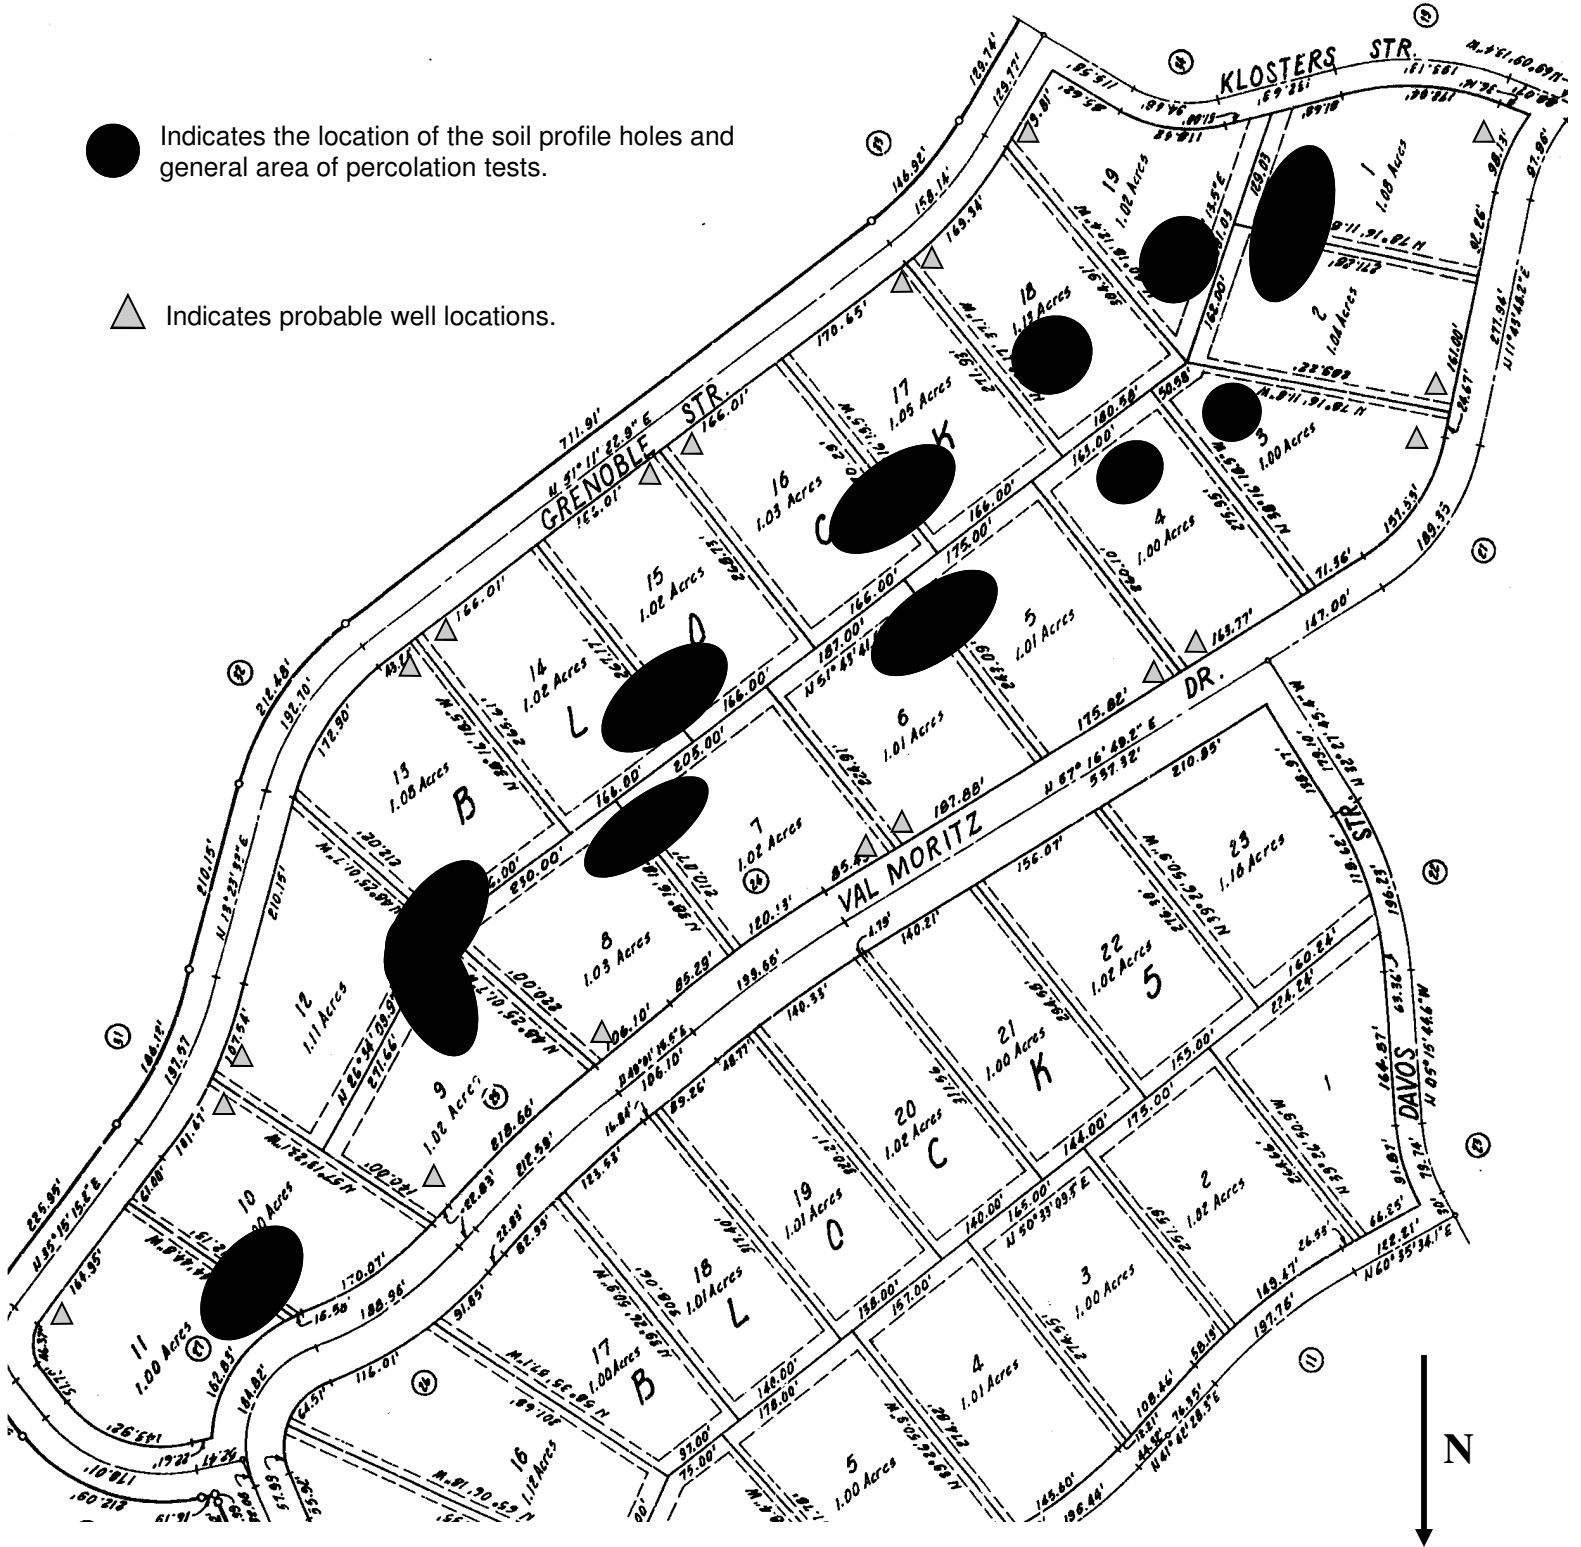
● Indicates the location of the soil profile holes and general area of percolation tests.

▲ Indicates probable well locations.

NOTES: The ground was very moist on the surface near the property line with Lot 18.
This general area seems to be somewhat more damp than others.
When designing the OWS the site of the drainfield should avoid these damp areas.
