# **VAL MORITZ VILLAGE**

## **FEASIBILITY REPORT ON INDIVIDUAL ONSITE WASTEWATER SYSTEMS FOR FILING 2, BLOCK 5**

**Prepared by:  
Shannon Engineering, Inc.**

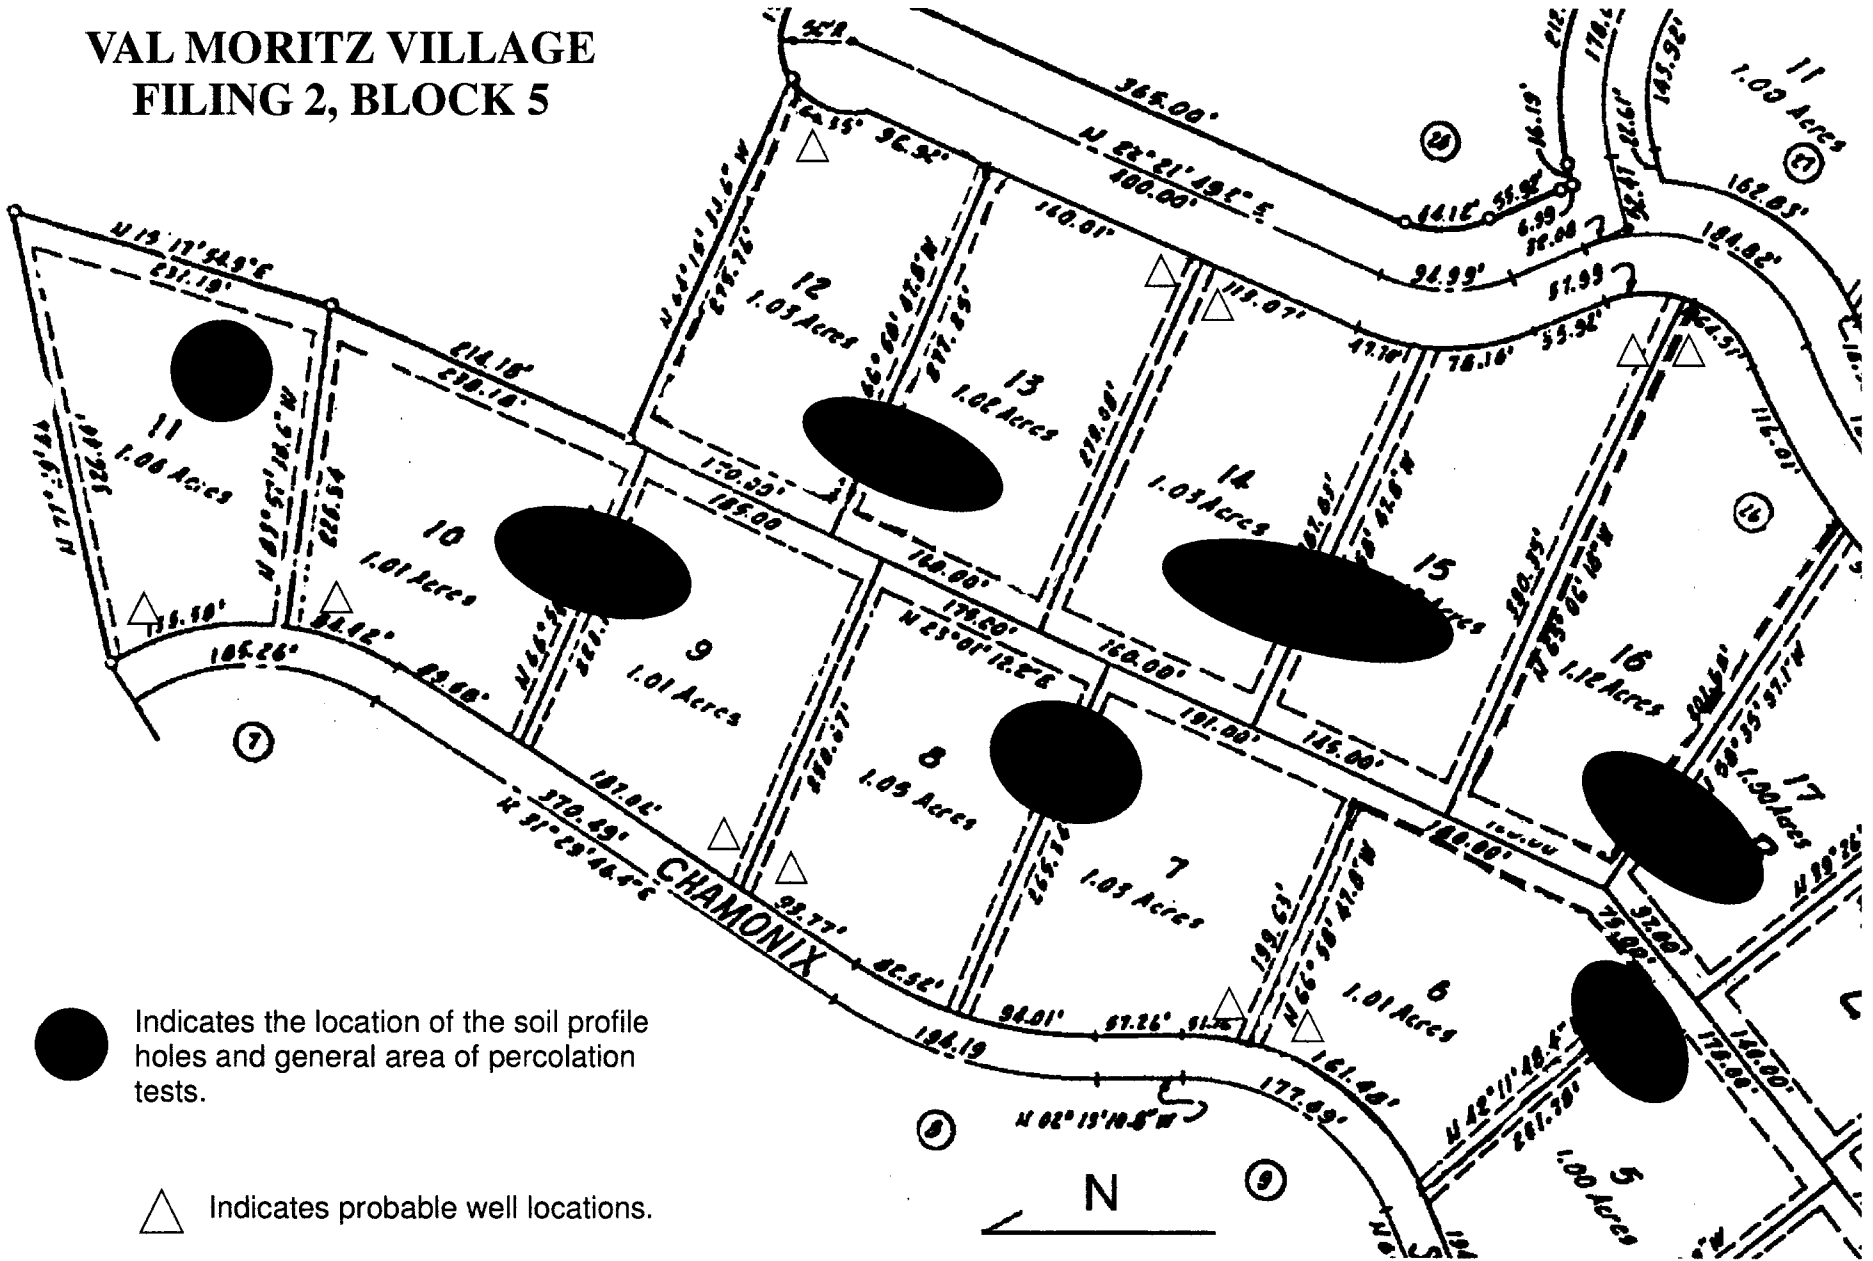
# VAL MORITZ VILLAGE FILING 2, BLOCK 5

Indicates the location of the soil profile holes and general area of percolation tests.

Indicates probable well locations.
